# Speed of Healing following Debridement of a Charcot Foot wound using the Medaxis debritom+ micro water jet technology

Florence Summers DPM, Audra R Siegel DPM, Christopher K Bromley DPM, Premier Medical Group, Poughkeepsie NY, October 2020

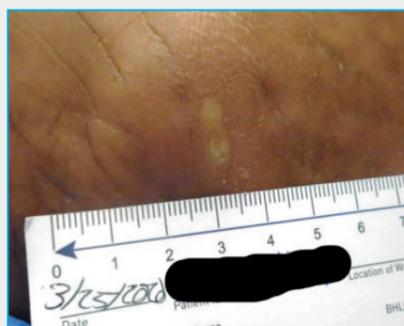
Wound Day 1

Patient presents as an emergency with complaints of a blister on the bottom of her right foot that was noticed the night before. Blister was located on the plantar aspect of the right foot, with edema and erythema present. Blister was debrided utilizing a #20 blade. Wound measurements were 1 x 0.3 x 0.2 cm. Culture was taken. Triple antibiotic ointment and a dry sterile dressing was applied and patient was placed on Keflex. Weekly sharp debridement with localized wound care led to moderate improvement.

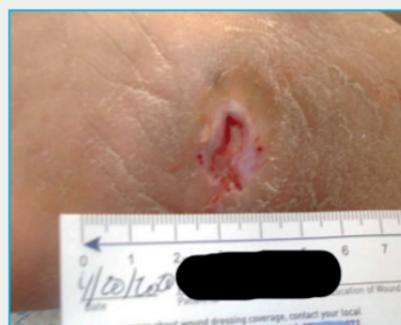
Wound Day 26

Patient again presented as an emergency. Significant drainage is noted on the dressings and erythema is again noted. Ulceration increased dramatically to 1.5 x 1.0 x 0.2 cm, and again sharp debridement was performed and a culture taken. Patient was again placed on Keflex and a dressing with Acticoat 7 was applied.

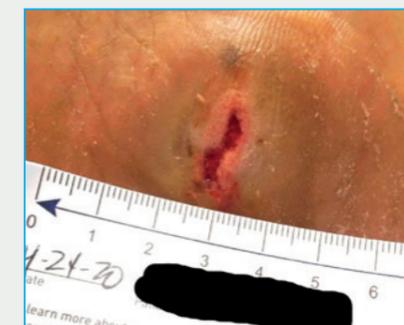
Wound Day 30

Patient returned to clinic. Wound showed no signs of infection with some improvement in ulceration, however continued drainage was noted. Ulceration measured 1.5 x 0.3 x 0.2 cm. To expedite healing, reaming was performed utilizing the Medaxis debritom+. A dressing including Acticoat 7 was applied.

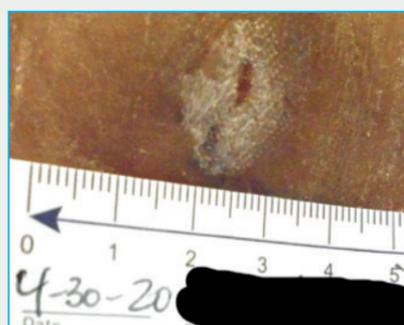
Wound Day 36

Patient returns to clinic. No signs of infection and no drainage is noted. Ulceration is markedly improved, measuring 0.3 x 0.1 x 0.1 cm. No further debridement was required. Acticoat 7 dressing was applied.

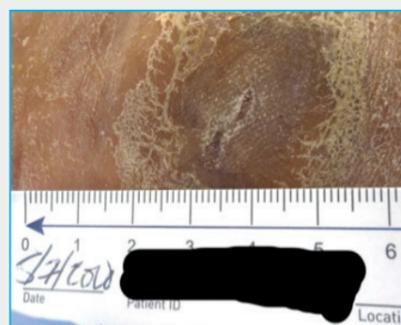
Wound Day 43

Patient returns to clinic. Ulceration is closed.

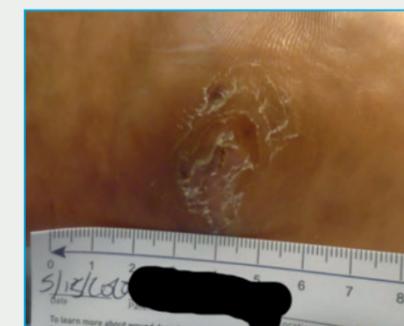
Wound Day 51

Ulceration remains closed

After multiple treatments with sharp debridement over the course of 4.5 weeks, the wound failed to heal. Subsequently a single debridement performed with the Medaxis debritom+ micro water jet technology device, resulted in closure of the wound in under 1 week. This device proved to be simple to use, and efficacious in facilitating wound healing.
